Scheme profile

Scheme code: BS\07\LCN\WFO.13

South Access Road LB Waltham Forest

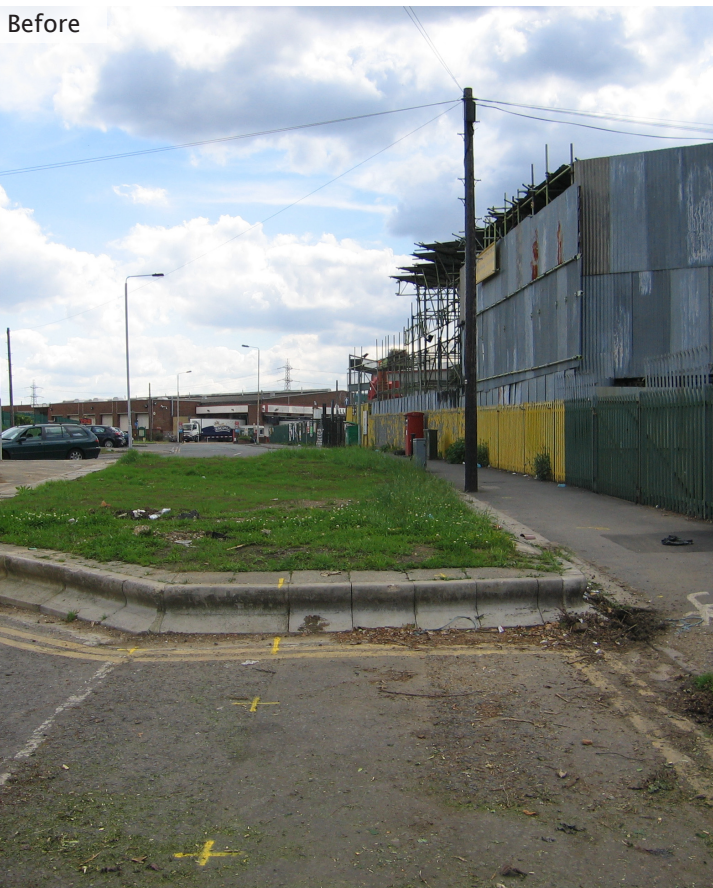
Before

- Low traffic flows
- Generally poor cycling conditions
- Poor quality shared use path with uneven surface and excessive amounts of street furniture
- Debris on the path

Due to the nature and location of the existing facility, there were problems with debris which was always on and around the path. Access onto the path involved a sharp turn, increasing the possibility of conflict with pedestrians whilst the path itself was uneven and cluttered with bollards, telegraph poles and lamp columns that hindered cyclists.

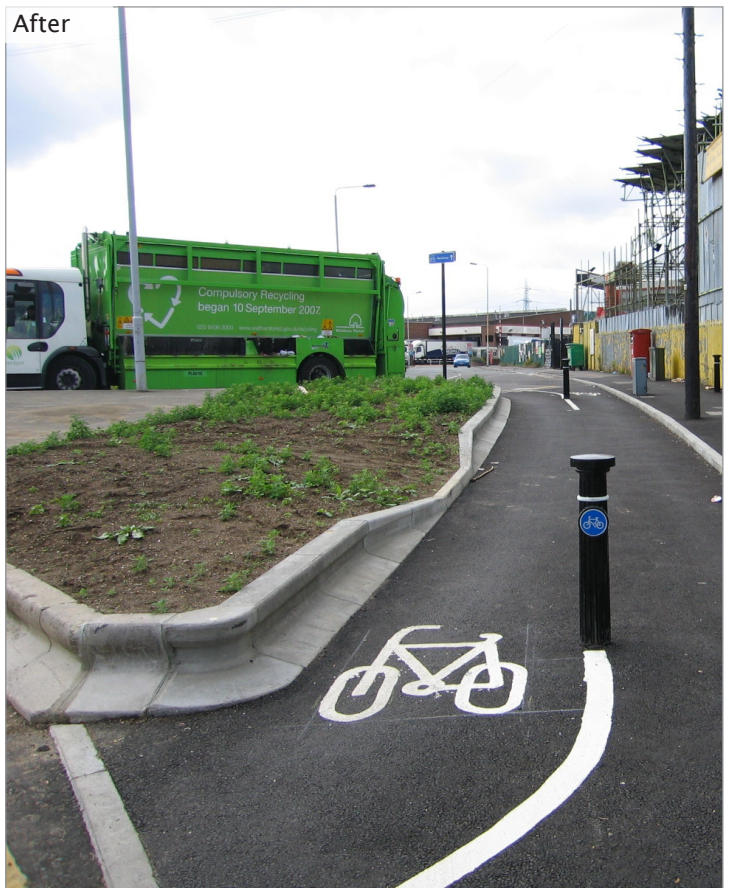
After

- Conversion of shared-use path to footway
- Two-way cycle track
- Resurfacing
- Drop kerbs
- Landscaping

In order to implement a scheme that met stakeholder expectations, whilst preventing unauthorised vehicles from accessing the cycle track, more room was gained by cutting through a grassed road closure that was bordered by trief kerbs. The old shared-use path was converted to a footpath with a two-way cycle track built alongside it. Both were resurfaced to allow for improved comfort and the kerb reinstated, along with bollards at either end of the track, to stop motor vehicles gaining access. A slight curve and drop kerbs at both ends allows cyclists to use the track without losing momentum and the segregation between cycle track and footpath minimises conflict between cyclists and pedestrians. To complete the area, and minimise damage to the surroundings, the grass verge was reseeded and a
