## A3 West Hill Wandsworth

## Scheme Reference: SC/0454/001/004

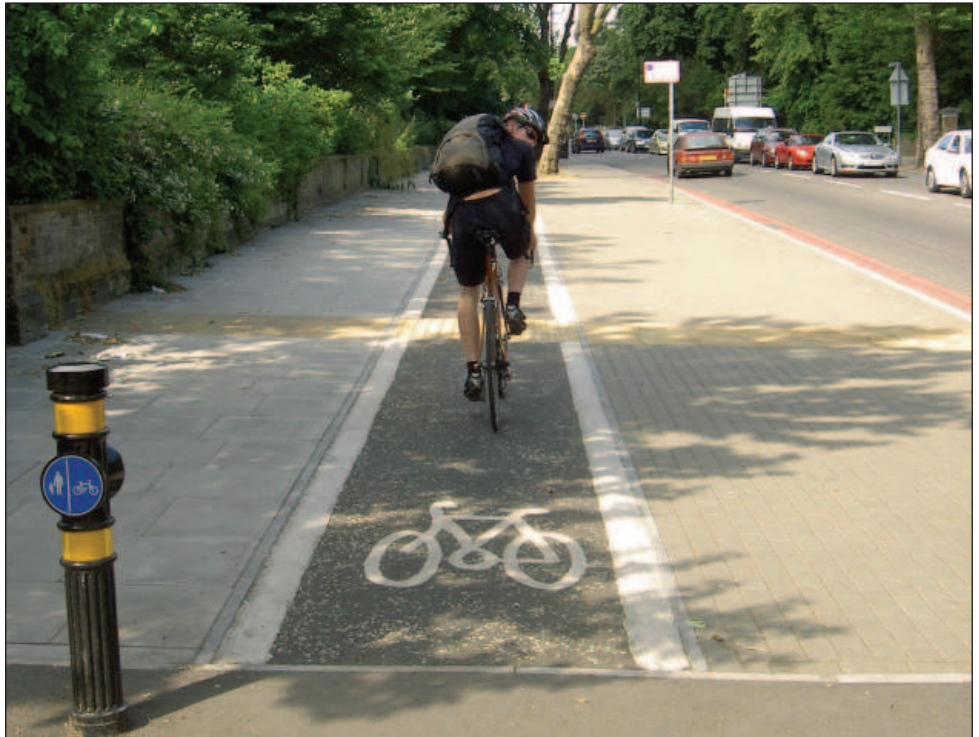
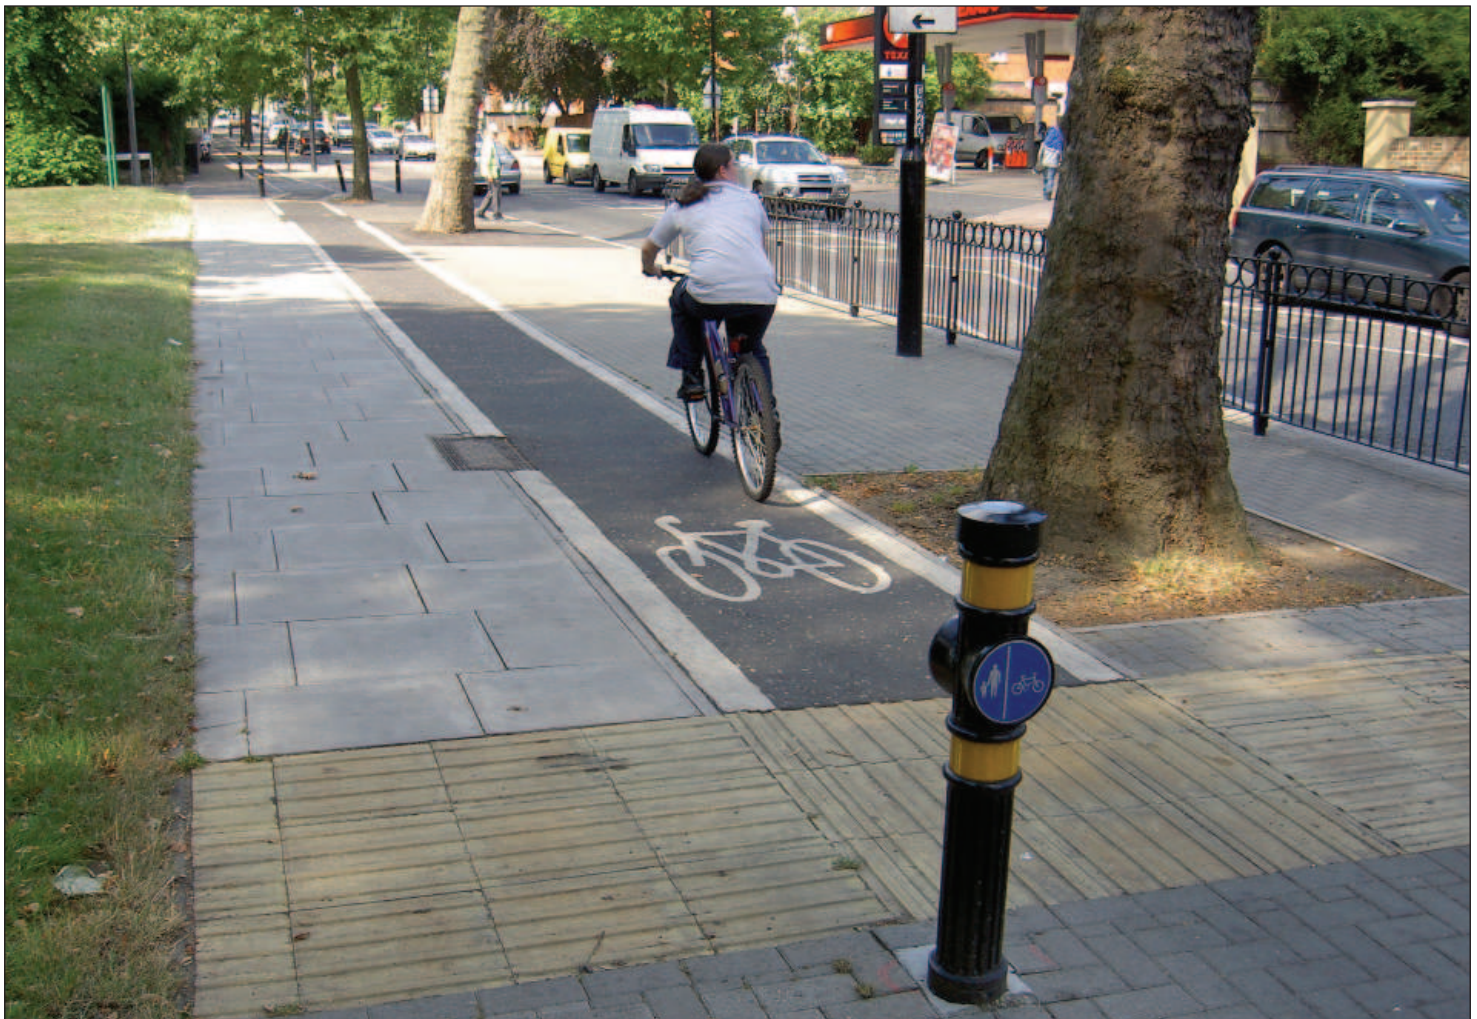
**Below and right:** the uphill segregated cycle track in use.

Most commuter cyclists were using the downhill cycle lane, although a few cyclists were using the track at all times of the day.

The questionnaire asked both cyclists and pedestrians for their views. Cyclists were generally favourable with the main complaint that the track surface could have been smoother, it was hand laid HRA (asphalt). Pedestrians were slightly critical overall, with some complaining of some excessive cyclists' speeds. With this particular scheme there had been few benefits for pedestrians, normally more pedestrian gains can be incorporated.

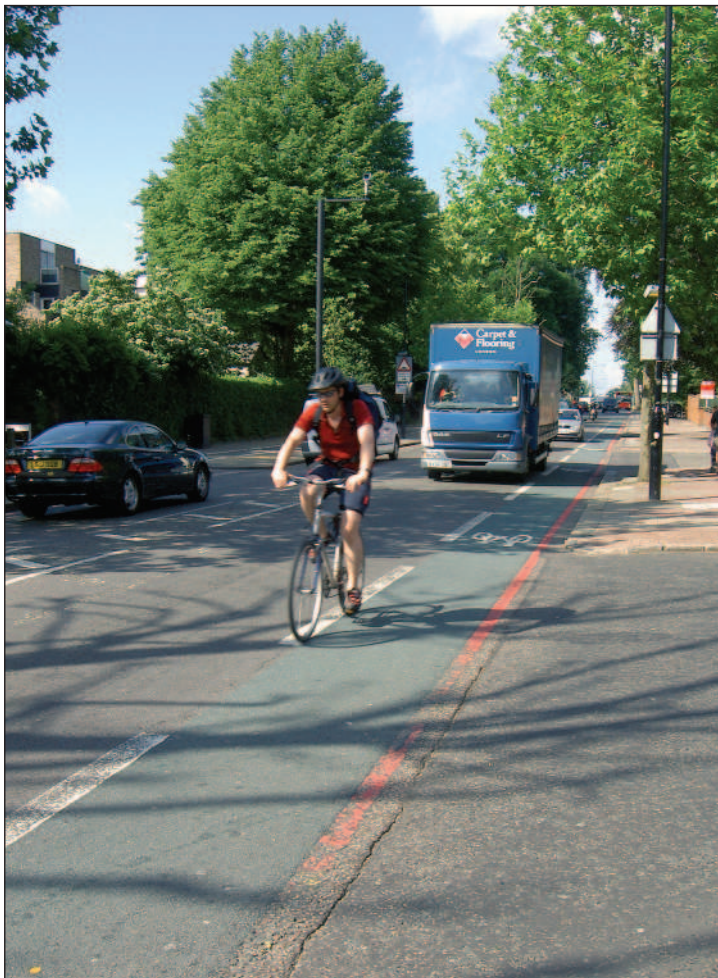
**Below:** the downhill cycle lane in use.

- Many motorists turning into a heavily used side-road did not seem to expect cyclists coming downhill in the cycle lane, despite clear cycle lane markings.

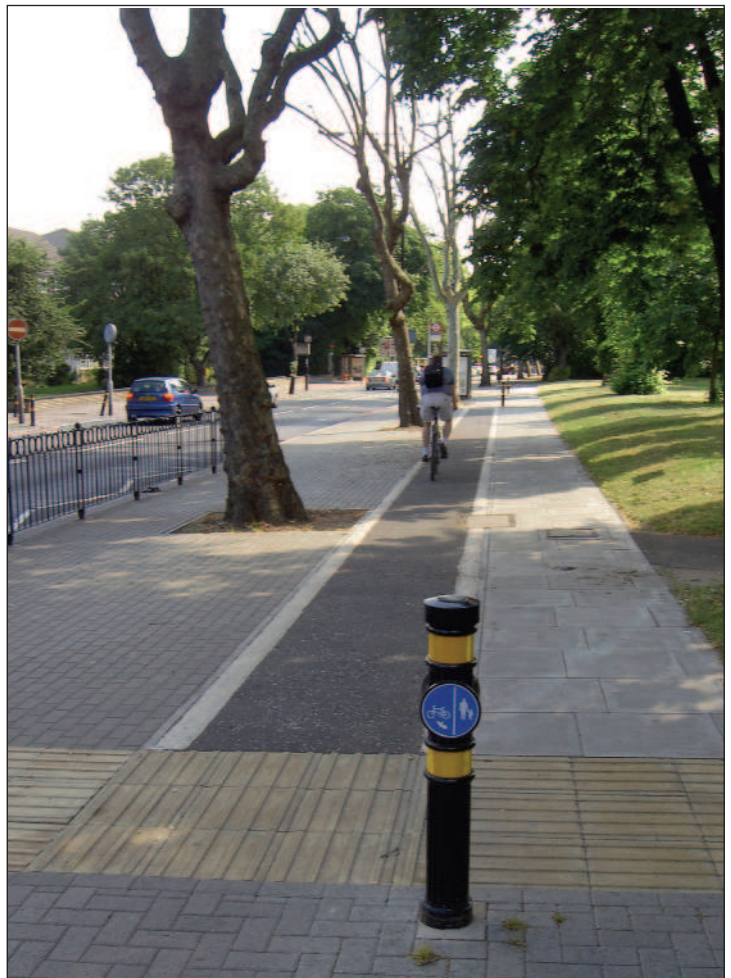
**Below right:** the cycle track being used downhill.
