South Carriage Drive City of Westminster

Description

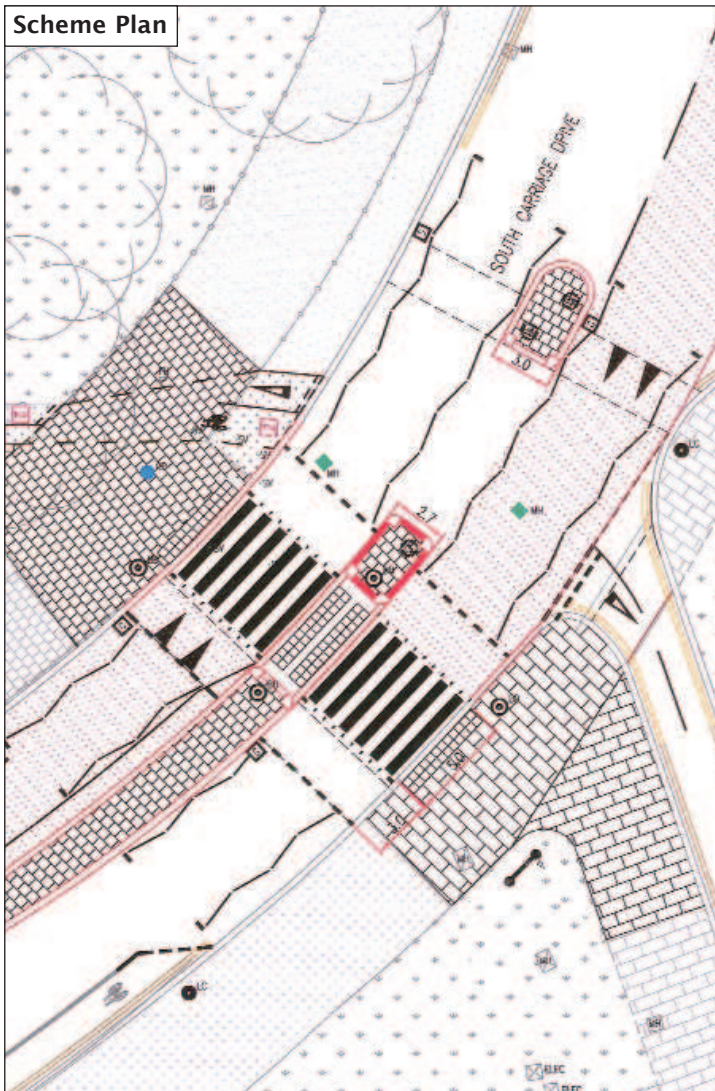
Scheme Plan

- Un-signalised parallel cycle crossing adjacent to a Zebra crossing
- LCDS Ref CCE/C19
- Stage 1 & 2 Safety Audit completed
- Stage 3 Safety Audit still to be completed
- Raised table - tarmac
- Blocked paving at entry/exit points
- Granite kerbing
- Give way markings

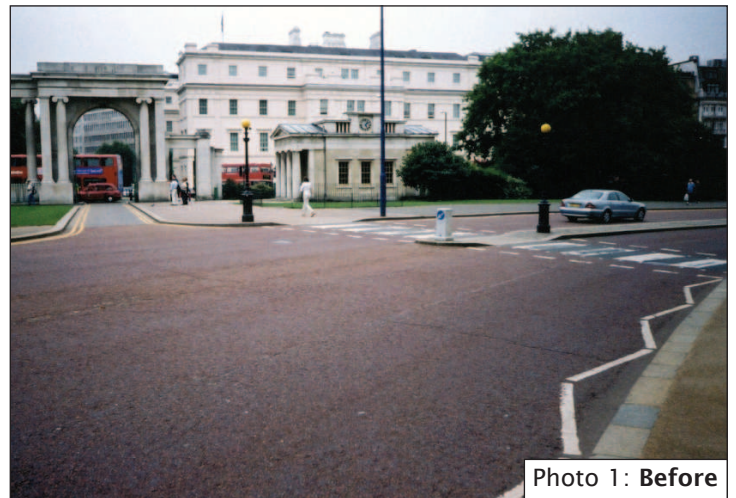
Photo 1: Before

- Crossing of road with 30mph speed limit
- High pedestrian density
- High cycle flows
- Royal Parks is the highway authority
