Berrylands Station LB Kingston upon Thames

Scheme details

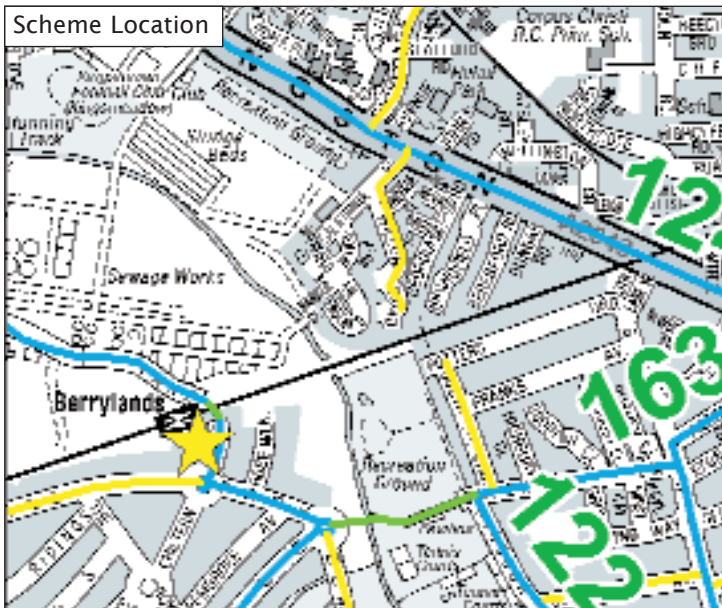
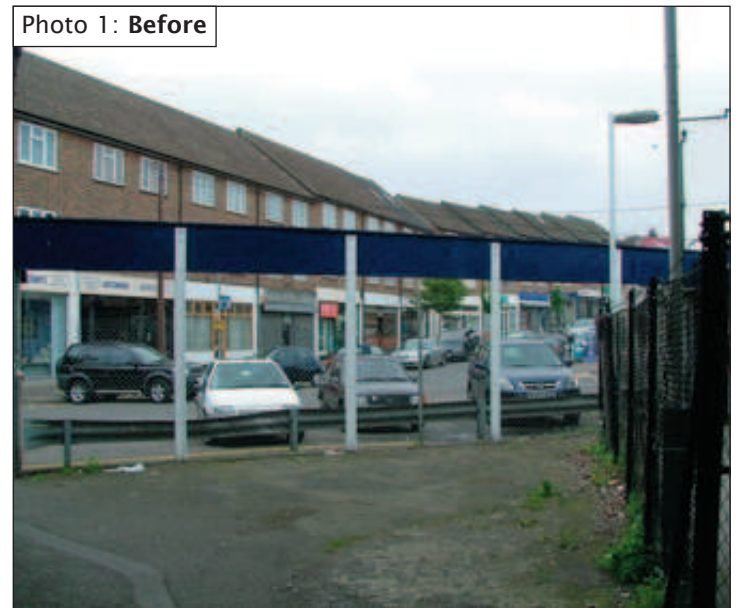
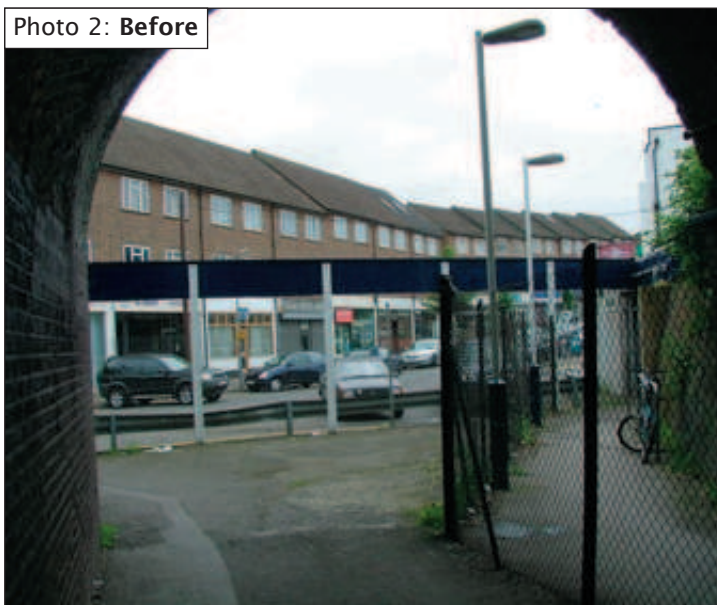
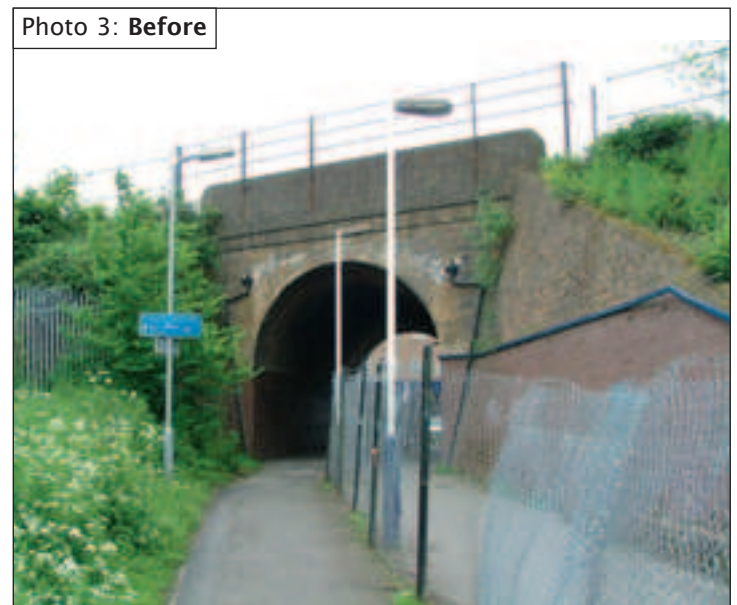
- Chiltern Drive: the original layout was very unsightly, unattractive and difficult to use.
- Chiltern Drive: cyclists were required to dismount when passing through the arch but rarely did so resulting in potential for conflict between users.

- View from Lower Marsh Lane: showing the unsightly layout and the potential for conflict between cyclists and pedestrians.
- Chiltern Drive: pedestrian access to the station and the pathway under the railway bridge was straightened out and is now more direct.
