Cable Street LB Tower hamlets

Description of the scheme

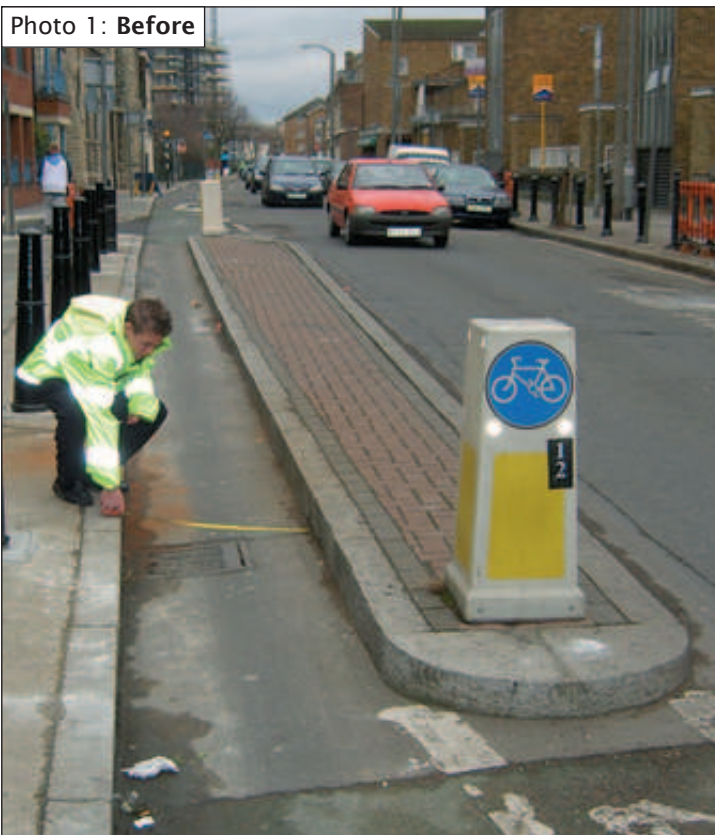
Photo 1: Before

1. Inspecting an existing cycle lane.
2. Cyclists travelled against the traffic at carriageway level.
3. Cycle facilities are now fully segregated.
Note: The signage on this section is under review.
- 4 & 5. Cable Street before/after scheme completion. Note: edge strip has not been installed and 1008 markings should be used as the centreline.
- 6 & 7. Cycle lane was raised to footpath level and widened to allow flow of cycle traffic in both directions. Note: the extent and style of guardrailing maybe excessive.
8. Note: Zebra layout is non-standard and the intermediate direction arrows are unnecessary.

This scheme identified some key problems faced by cyclists including a lack of continuity in cycle lanes and safety issues. The "photos illustrate that the existing cycle lane contra-flow, although designed for single-lane use by cyclists travelling against the traffic, was also being used by cyclists travelling with the traffic. At such times of conflicting use, cyclists travelling against the traffic were forced onto the carriageway. Although the existing scheme was a valid solution under DFT and LCDS guidelines, it was decided that the scheme should be up-graded and widened due to these safety issues.
