Scheme profile

Scheme code: BS\07\LCN\BRE.10

Palermo Road Junction LB Brent

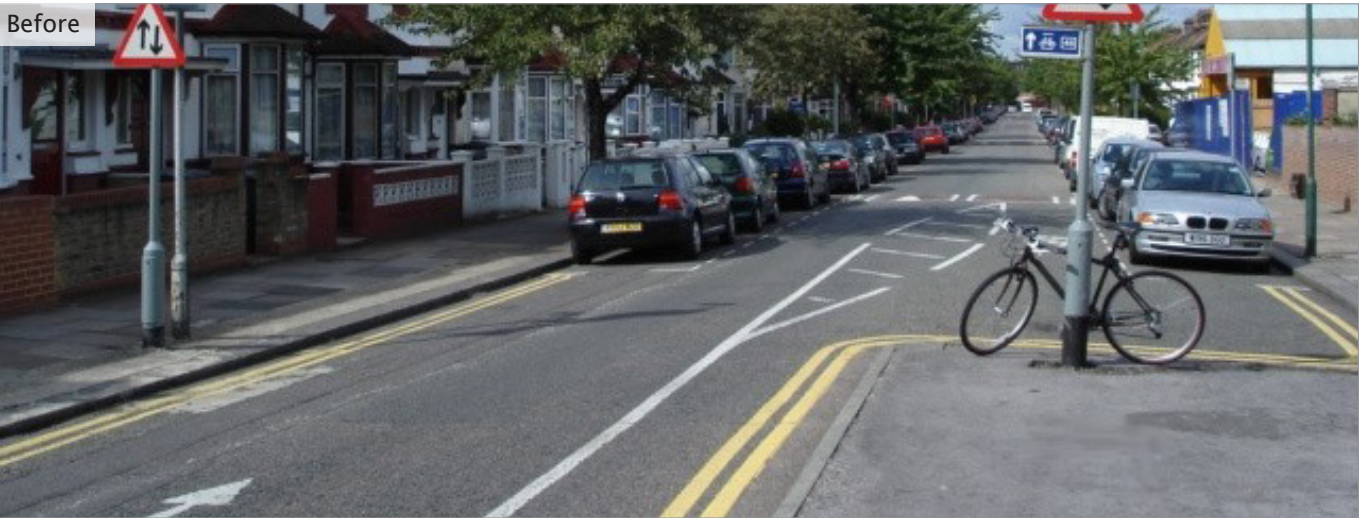
Before

- Ineffective mini-roundabout with poor visibility for riders
- Vehicles regularly pass through without reducing speed
- Speed cushions

Speed cushions had previously been installed along the length of Palermo Road to address ongoing issues of excessive vehicle speeds. The roundabout at the junction with Wrottesley Road posed particular problems for cyclists due to the high vehicle speeds and generally poor visibility. In its current form, the roundabout offered no vertical calming and minimal deflection, allowing motor vehicles to regularly pass through without reducing their speed.

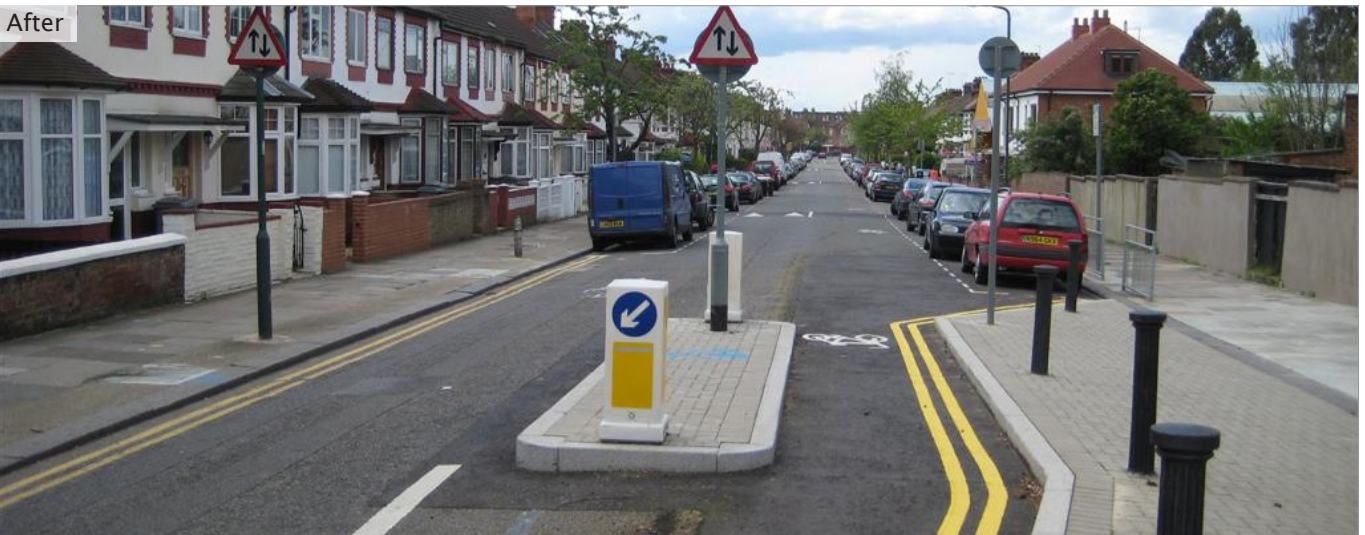
After

- Conversion of 6 speed cushions to sinusoidal humps
- Kerb build outs
- Roundabout works and entry treatments for speed reduction
- Redesign of cycle contraflow

prepared which involved conversion of six existing speed cushions in Palermo Road to sinusoidal profile humps, in accordance with LCDS, for more comfortable cycling. The CRISP study highlighted a desire for sinusoidal humps to replace these cushions, as with all other speed cushions on LCN+ Links across the Borough. Initially, two trial humps were installed to gauge the response from local cyclists, ensure the contractors could construct them within tolerance, and as reference installations for comparative speed surveys. The trial humps were met with a positive response, construction problems were ironed out and vehicle speeds reduced, enabling completion of the remainder of Palermo Road, and other roads across the borough. Problems associated with the mini-roundabout were addressed by tightening the geometry with kerb

build outs and implementing an entry treatment on one arm to further reduce the speed of vehicles turning into or out of Wrottesley Road.
